Subchondroplasty of the Ankle at UCDHS

Clinical and Radiographic Characteristics of Patients Treated with Subchondroplasty of Ankle

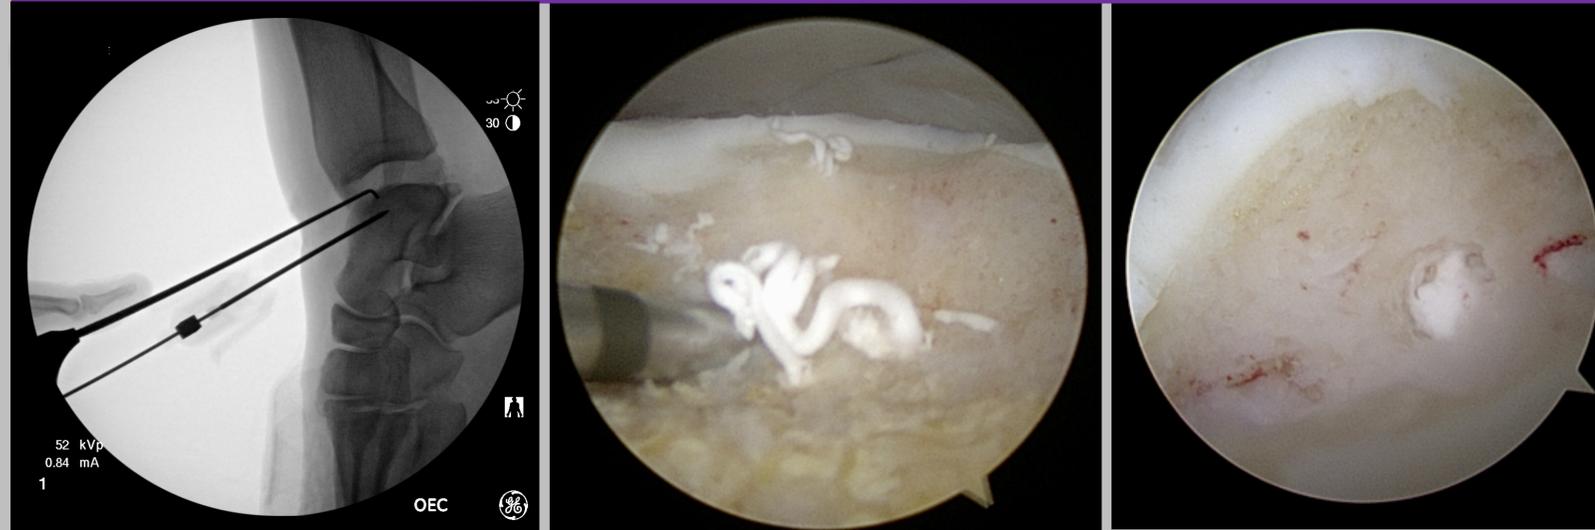
Figure 1: Fluoroscopic image of treatment of talar osteochondral defect. Fluoroscopy is commonly used to guide procedure and confirm location of injection.

Figure 2: Arthroscopic image of active injection of calcium tri-phosphate cement into OCD lesion following micro fracture.

Figure 3: Arthroscopic image of OCD lesion after calcium tri-phosphate injection, confirming fill of the defect.

SCP is performed with patients under general anesthesia openly or arthroscopically depending upon any concomitant procedures. A calcium tri-phosphate cement is prepared and injected into the bone to fill the defect in hopes to decrease pain and further edema of the bone. In most cases SCP is an outpatient surgery and patients are able to return home the same day.
